Piper Aircraft Corporation
Vero Beach, Florida, U.S.A.

No. 1001

Engine Mount
Inspection/Modification

PA-46-310P Malibu

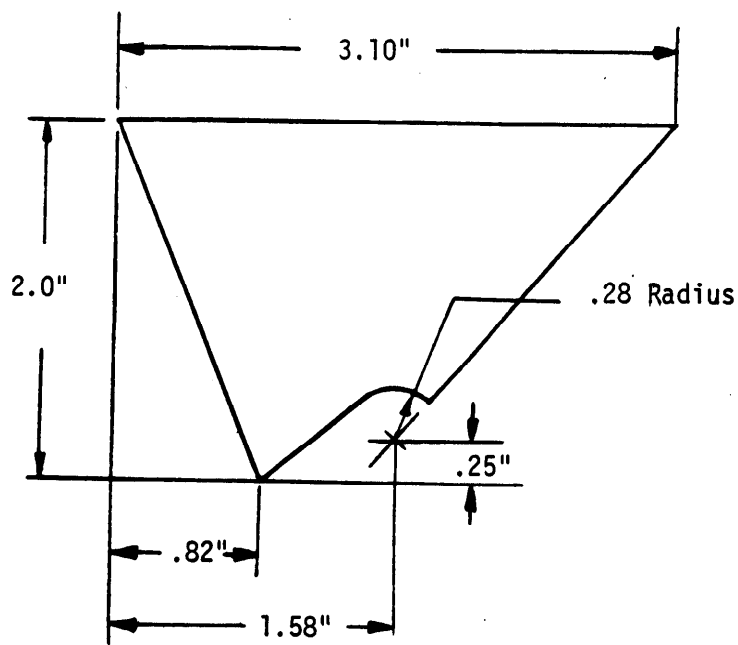
P/N 84010-48 Gusset May Be Fabricated
From .062" 4130N Steel

NOTE: Gusset may be fabricated from .062" 4130N steel. Refer to Sketch 'A', Figure 3 for dimensions.

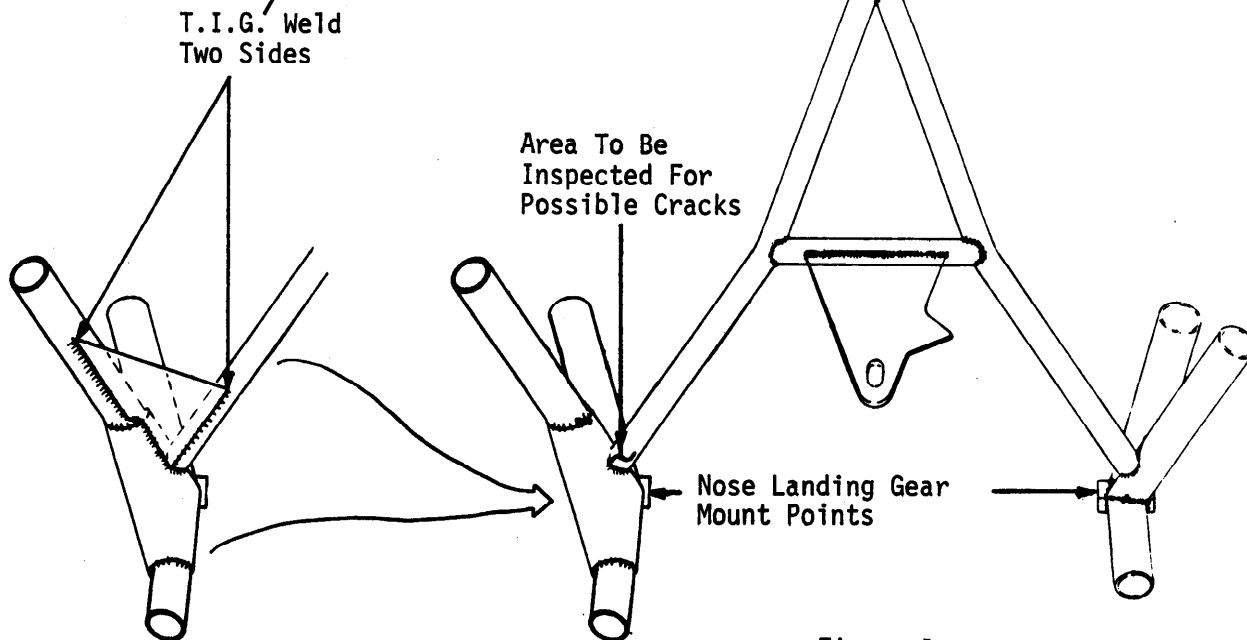
SKETCH "A"

Field reports have been received and examination
of one returned engine mount revealed cracking at the cluster weld near the
righthand nose landing gear mount point.

Area To Be
Inspected For
Possible Cracks

Nose Landing Gear
Mount Points

1. Place aircraft on jacks.
2. Remove engine cowl.
3. Remove righthand turbocharger.
4. Remove engine airbox.
5. Remove nose landing gear assembly.
6. Remove clamps and ties as required to position wire harnesses and hoses
clear of work area.
7. Attach a suitable hoist to engine and relieve loading on the engine mount
prior to any welding.
8. Visually inspect engine mount for cracking at area indicated using a dye
penetrant procedure. Refer to Sketch 'A' Figure 1 attached.
9. If cracking is indicated, clean affected area and repair by TIG welding.

10. After inspection and/or repair, locate and TIG weld in place along two (2) sides, one (1) each gusset, Piper Part Number 84010-48. Refer to Sketch 'A', Figure 2.
